CRUSTAL DEFORMATION ASSOCIATED WITH THE 1960 EARTHQUAKE EVENTS IN THE SOUTH OF CHILE

Felipe Villalobos¹

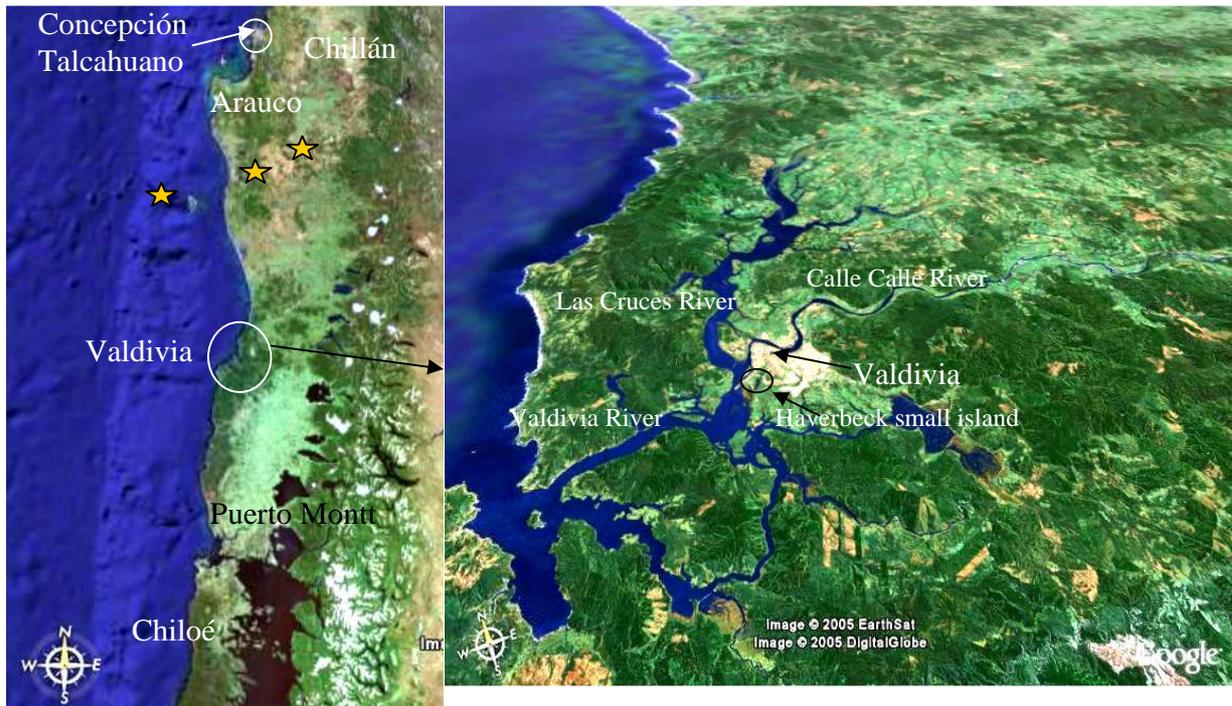
Figure 1: (a) View of the whole area affected (stars represent possible epicentre locations) and (b) view of Valdivia city and surroundings

The further north city seriously affected was Chillán with around 20% of buildings severely damaged. Figure 1 shows the area affected and main cities and a close up to Valdivia. A description of structural damage in Talcahuano, Concepción and Puerto Montt, with special attention in Valdivia can be found in Steinbrugge and Flores (1963). A geotechnical description of failures can be found in Duke and Leeds (1963). Although the damages propagated from Concepción to Chiloé in the bottom south, the city most drastically affected was Valdivia and for that reason this earthquake is called the Valdivia Earthquake. Figures 2a and 2b show almost the same place of the Valdivia promenade before and after the earthquake. The river floods the promenade, which is equivalent of at least 2 m of subsidence. Figures 3a and 3b show pictures taken by Karl Steinbrugge on 19th June 1960 further upstream, where it is clear to observe the promenade sinking of around 2 m due to subsidence.

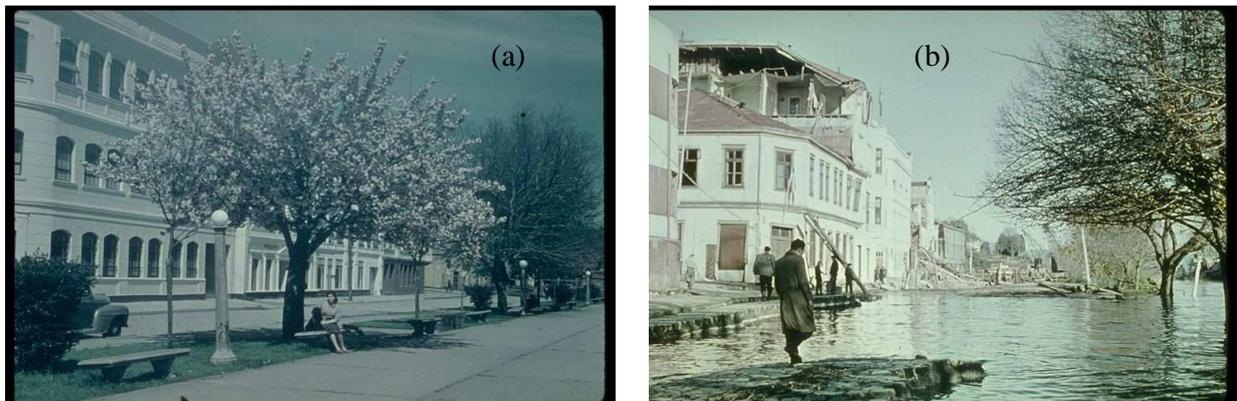
Figure 2: (a) Valdivia promenade before the earthquakes and (b) after the earthquakes (Steinbrugge and Flores, 1963)

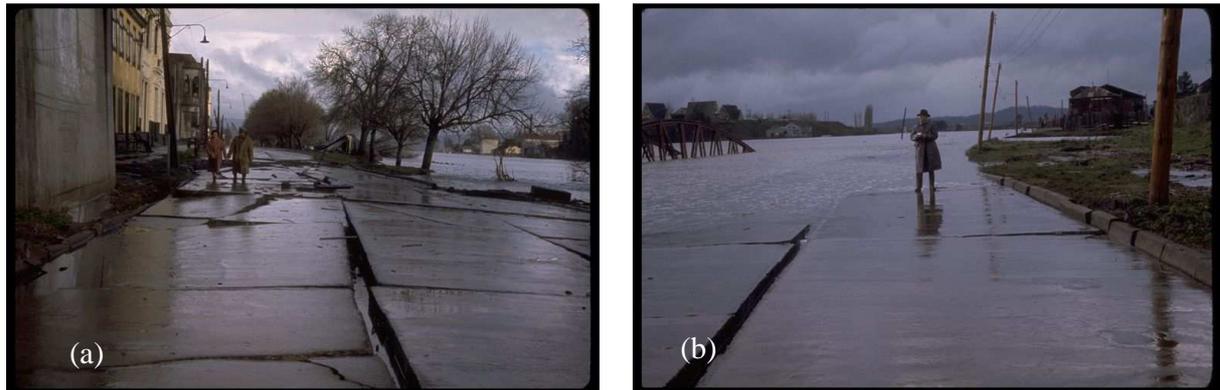
Figure 3: Road along the promenade showing concrete pavement distorted, broken and tilted towards the river (a) under Pedro de Valdivia Bridge and (b) passing the bridge upstream (Steinbrugge and Flores, 1963)

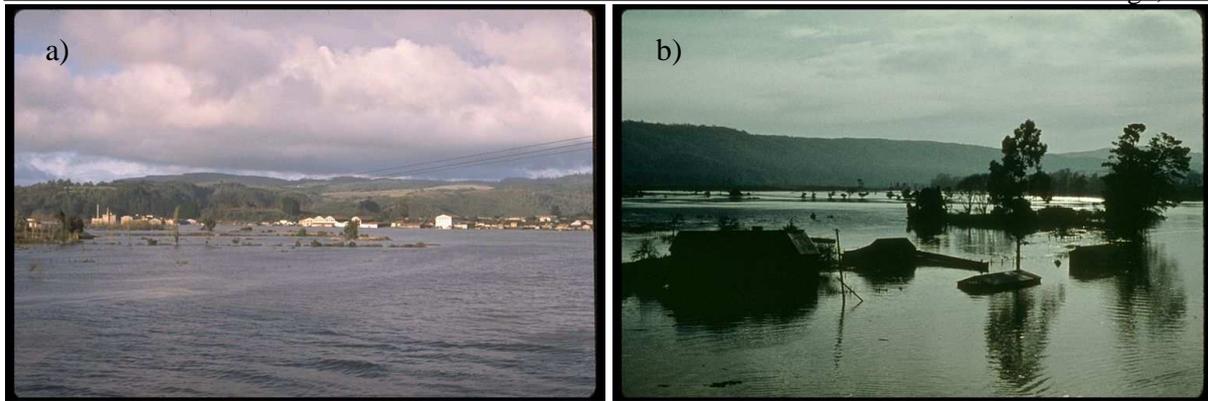
Figure 4: (a) View from the Valdivia River towards Miraflores showing the Haverbeck Islet under water and (b) closer view of Haverbeck Islet from Miraflores (Steinbrugge and Flores, 1963)

During the first hours after the main earthquake, wetlands and low lands along streams between Imperial River and the south of Chiloé were flooded. Figure 4 shows the Haverbeck small island almost disappeared under water, only top of houses and trees are possible to distinguish. Weischet (1963) observed around 17:00 (local time) the Calle Calle River not only flowing upstream but also at a higher rate than when it flows downstream (see Figure 5b). Some days later, 30 km upstream of the river mouth marine fish and salty water were found. It took a couple of months to have freshwater again. The flood covered 15000 hectares of sowing land only around Valdivia (Figure 5a).

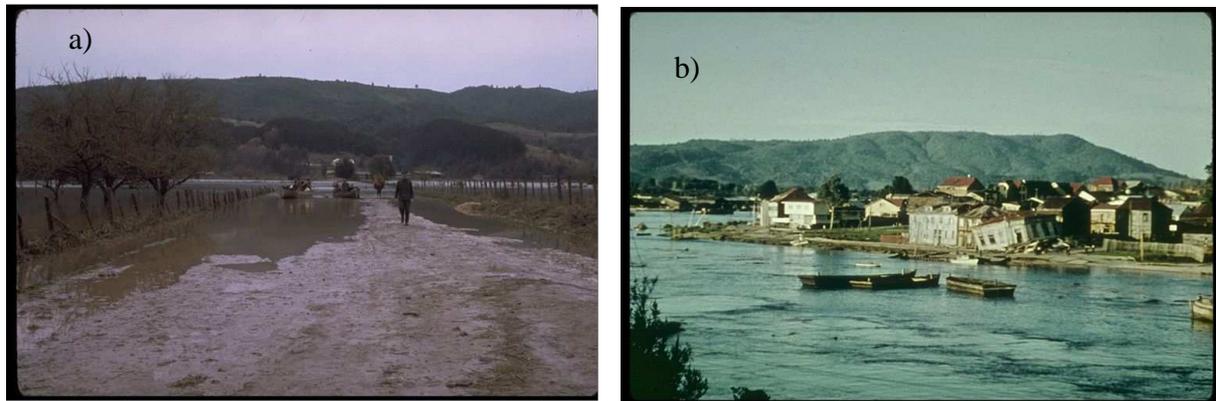
Figure 5: (a) Inundation of the country side around Valdivia and (b) drifted boats flowing upstream after passing the Pedro de Valdivia Bridge half an hour after the main earthquake (Steinbrugge and Flores, 1963)

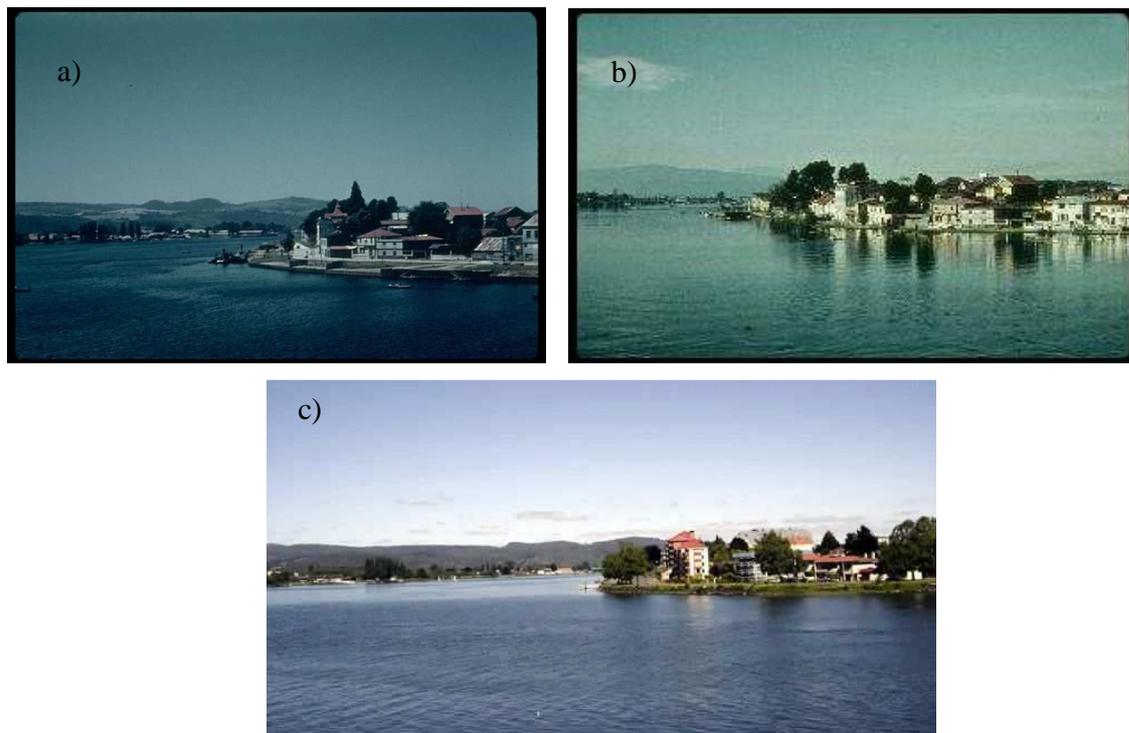
Figure 6: View of Valdivia from the Teja Island (a) before the 1960 earthquake, (b) immediately after (Steinbrugge and Flores, 1963) and (c) nowadays

From the facts described and evidences given by researchers who witnessed and studied the phenomena of subsidence and uplift caused by the 1960 earthquake, it is possible to raise some questions. A question is about the causes of flooding in Valdivia. Tsunami waves, heavy rain and controlled overflow of the Riñihue Lake occurred after the entrance of seawater in Valdivia around half an hour after the main quake, as can be seen in Figures 4a and 5b. Therefore, the causes of this flooding can be attributed to dynamic compaction of thick layers of sedimentary deposits and tectonic subsidence as pointed out by Weischet (1963). But even accepting these explanations remains the question about why Valdivia is today after 50 years not flooded. Figure 6 shows a sequence of pictures of Valdivia before the 1960 earthquake, immediately after the quake and today.

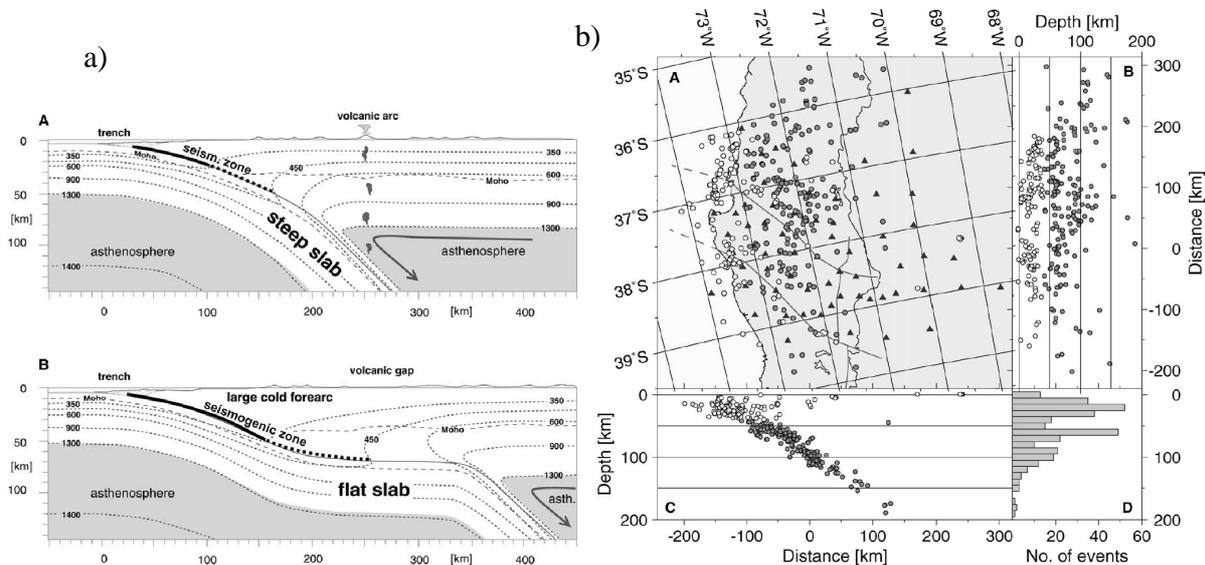
Figure 7: a) Wadati Benioff zone showing type of subduction A: steep slab in the south of the Andes and type of subduction B: flat slab in the north of the Andes (Gutscher, 2002) and b) results from a seismic recording campaign, white circles are events up to 40 km deep and black triangles are the recording stations. A: epicentres, B: hypocentres projected in the longitudinal direction, C: hypocentres showing the Benioff zone and D: depth frequency distribution of the seismic events (taken from Bohm *et al.*, 2002)

Figure 7b shows the Benioff zone delineated from a seismic recording work carried out in the Bío Bío and Araucanía Regions by Bohm *et al.* (2002). Despite the dispersion, it is possible to define an initial inclination of around 15° for the first 40 km followed by an inclination of around 36° for depths up to 180

km. However, the subduction zone around Valdivia and further south are not yet sufficiently studied. One option is to assume the same subduction configuration shown in Figure 7b for the Valdivia area. From this and knowing the aftershocks depths Cifuentes (1989) estimated the width of the rupture zone in 140 km.

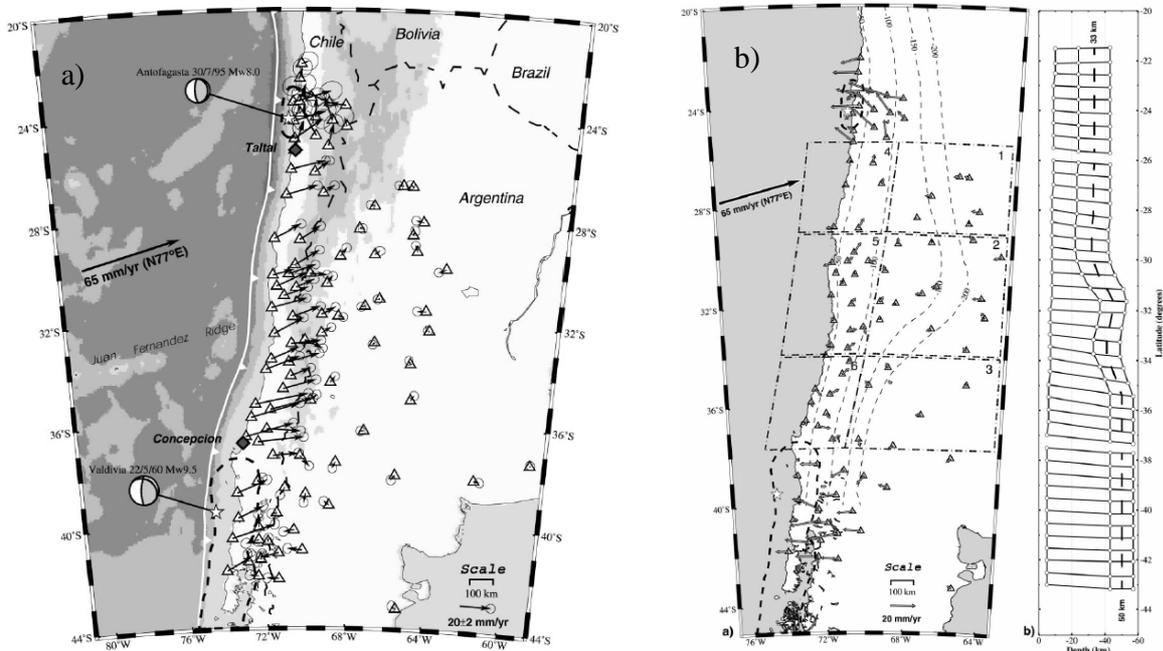
Figure 8: a) Velocity map obtained from of the GPS network SAGA in 1994 and 1996 campaigns. Two stars represent epicentres of the 1960 and 1995 earthquakes and dashed lines their rupture areas and b) resultant velocity fields obtained from removing the elastic part of the measured velocity vectors shown in a). Contour lines depict the Nazca plate depth in km and 6 areas delineated by straight lines, in between the two rupture zones in Antofagasta and south of Arauco, represent an inactive zone. Cross section of the seismogenic zone showing with a bold dash line an estimated average coupling depth (taken from Klotz *et al.*, 2001)

The work of Klotz *et al.* (2001) included also the centre and part of the south of Chile, which allows the analysis of the area affected by the 1960 earthquakes. Figure 8a shows a velocity field, by means of velocity vectors, between the latitudes 22°S and 42°S. In the central area between Taltal and Concepción (26°S and 37°S), the velocity vectors magnitude on the coast are relatively larger than the others (~35 mm/year). These vectors tend to follow the direction of convergence of the Nazca and South American plates. Looking at the top north and bottom south there are only some vectors closer to the trench which follow the convergence direction, the others seems to follow random directions.

The random orientation of the measured velocity vectors in the north and south of Chile shown in Figure 8a is a consequence of the previous large earthquakes in 1995 and 1960 respectively. Figure 8b shows a more regular orientation when elastic inter-seismic velocities are eliminated.

Klotz *et al.* (2001) estimated a resultant velocity field showed in Figure 8b, which is determined by removing the elastic part of the displacement rates obtained instrumentally. For details of elastic dislocation models see Klotz *et al.* (2001) and Hu *et al.* (2004). It can be observed in Figure 8b that the majority of the resultant velocity vectors on the two rupture zones are oriented towards the trench, *i.e.* in opposite direction of the Nazca plate convergence. These post-seismic movements are obviously associated to the previous seismic events, clearly for the more recent 1995 Antofagasta earthquake of $M_w = 8.0$ and incredibly for the 1960 Valdivia earthquake of $M_w = 9.5$. Since the measurement campaign was carried out in 1994 and 1996, it would be extremely valuable to verify the current state of movement in the south area.
